Cow Creek 2001 Stream Survey

The Santa Fe National Forest conducted stream surveys in the upper Cow Creek Watershed during the summer and fall of 2001. The streams included in the survey were Cow Creek, Elk Creek (tributary to Cow), and Sheep Creek (tributary to Elk). A total of 23.90 miles of stream were surveyed: 18.4 in Cow Creek, 4.0 in Elk Creek, and 1.5 in Sheep Creek. The results of the Elk and Sheep Creek stream surveys can be found in their respective stream inventory reports.

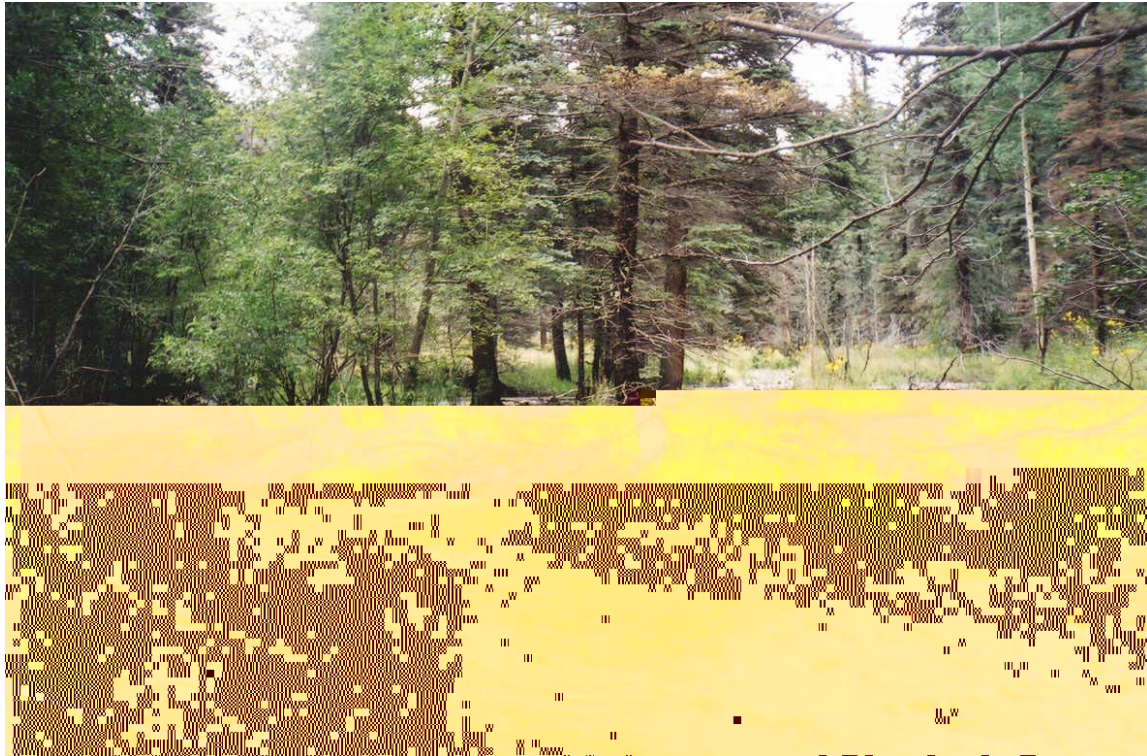
Due to the post-fire flashy condition of Cow Creek, the stream has changed its course in places to accommodate the increased volumes of water in the channel after rain events (see Photo 3). In addition, it has formed new side channels and braids. Particularly on private land where less standing trees were present, the stream at times was braided into several channels flowing through the grassy floodplain.

Photo 3. Reach 8, NSO133, R55. Typical braided riffle in Cow Creek after a light rain event (14 Aug 2001).

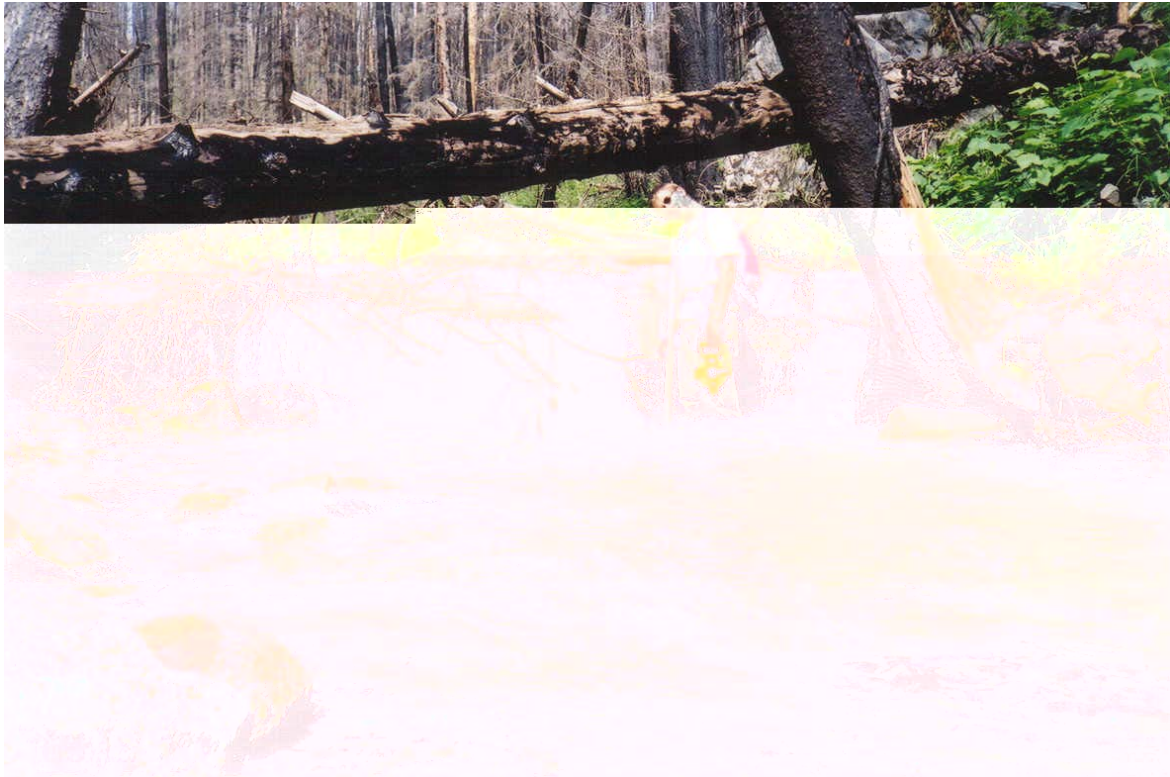
Photo 4. Reach 9, NSO212, F8. Waterfall over a log creating a plunge pool on Cow Creek. Note the fire-damaged trees falling in towards the stream (22 Aug 2001).

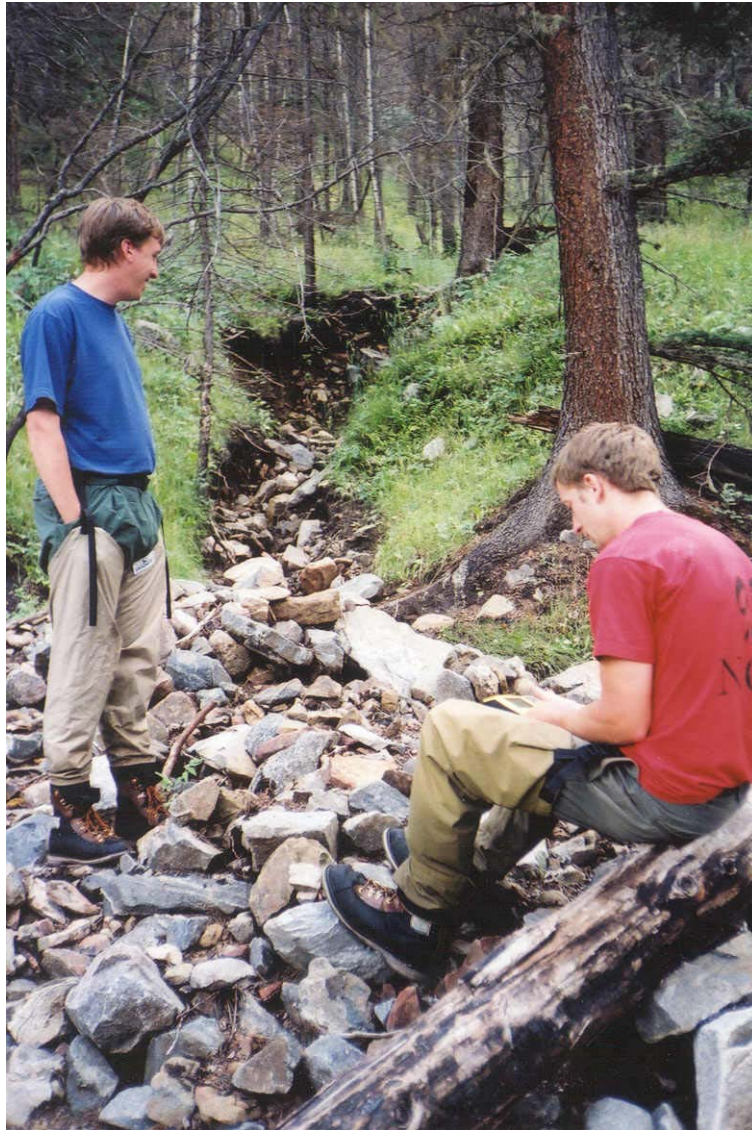
Photo 5. Reach 8, NSO134, T13. Small tributary to Cow Creek with a large boulder deposit. Vast quantities of large rocks were transported by summer rain events and deposited in fans such as this one (14 Aug 2001).

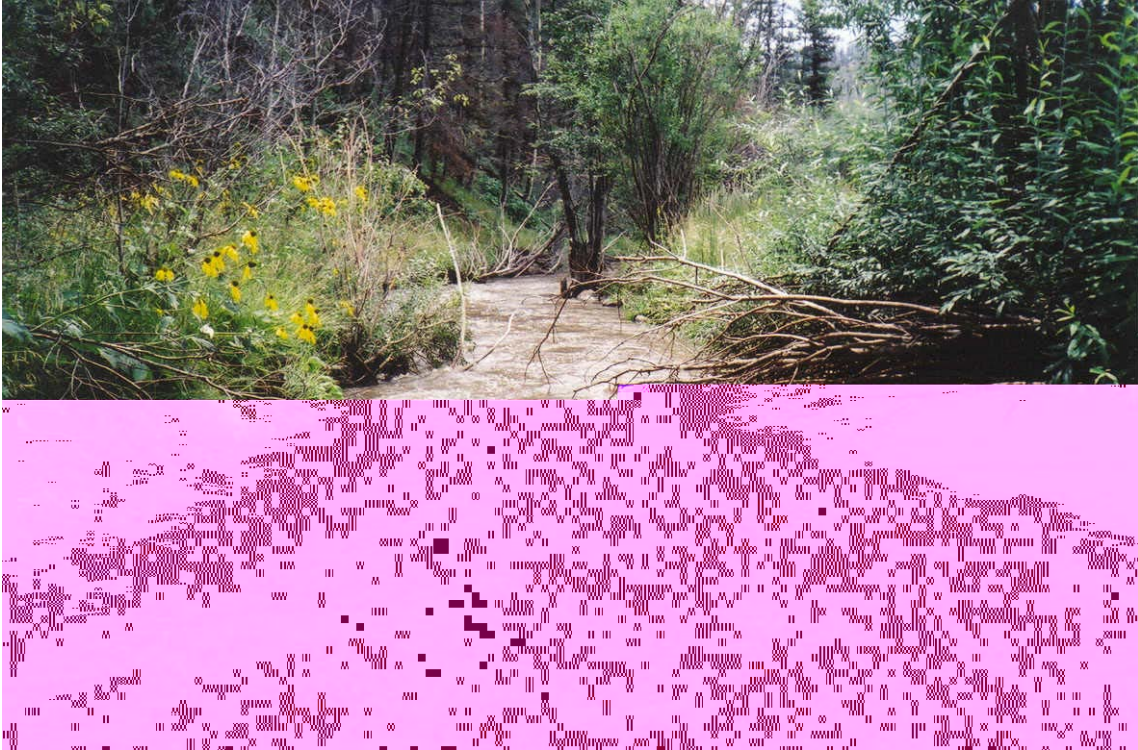
Photo 6. Reach 8, NSO 130, R53. Stream discharge of 42.5 CFS the day after a rain event (14 Aug 2001).

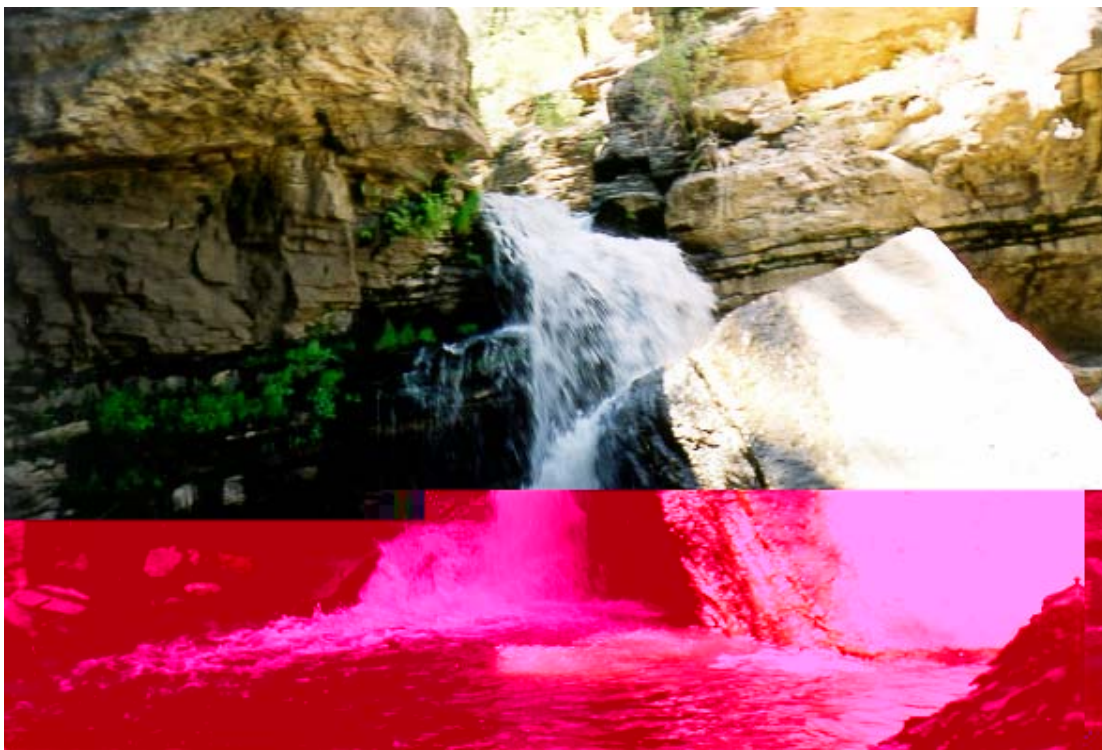
Photo 11. Reach 3, NSO 44, F4. 20' waterfall preventing upstream fish passage into the rest of Cow Creek (29 Jul 2001).

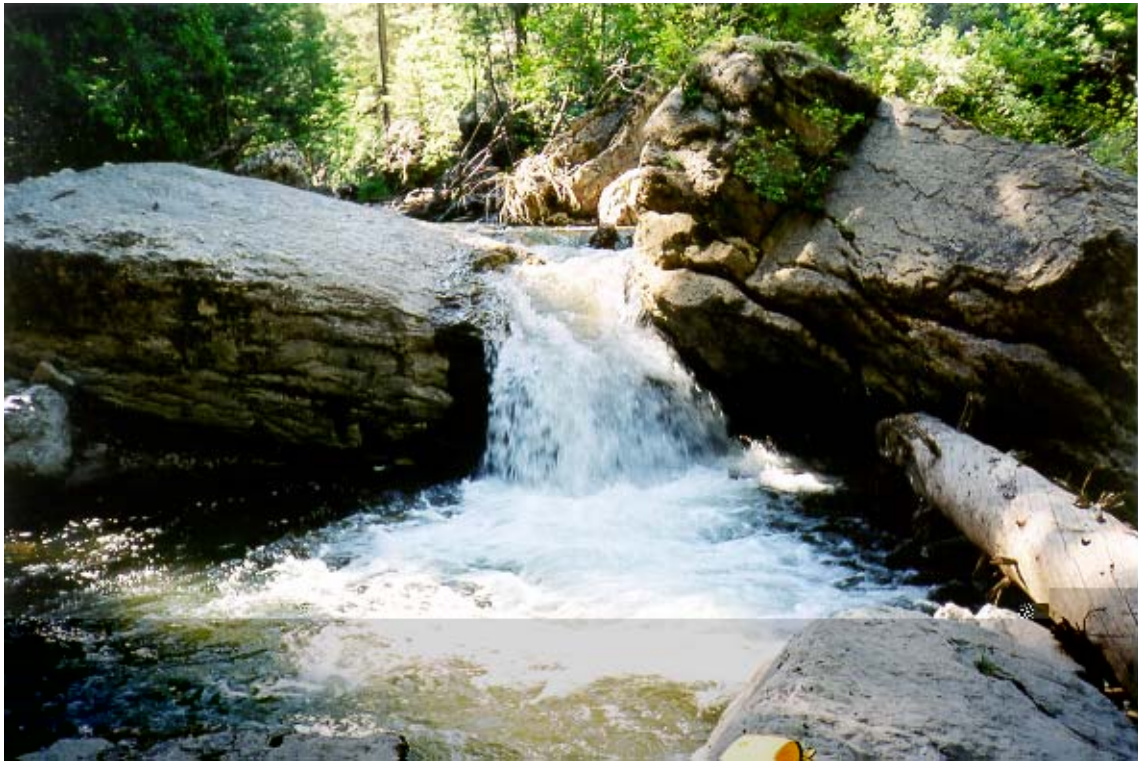
Photo 17. Chute / waterfall in Reach 2. Due to the pool depth, surveyors determined it is not a barrier to fish passage (Reach 2, NSO20, F1, 18 Jul 2002).

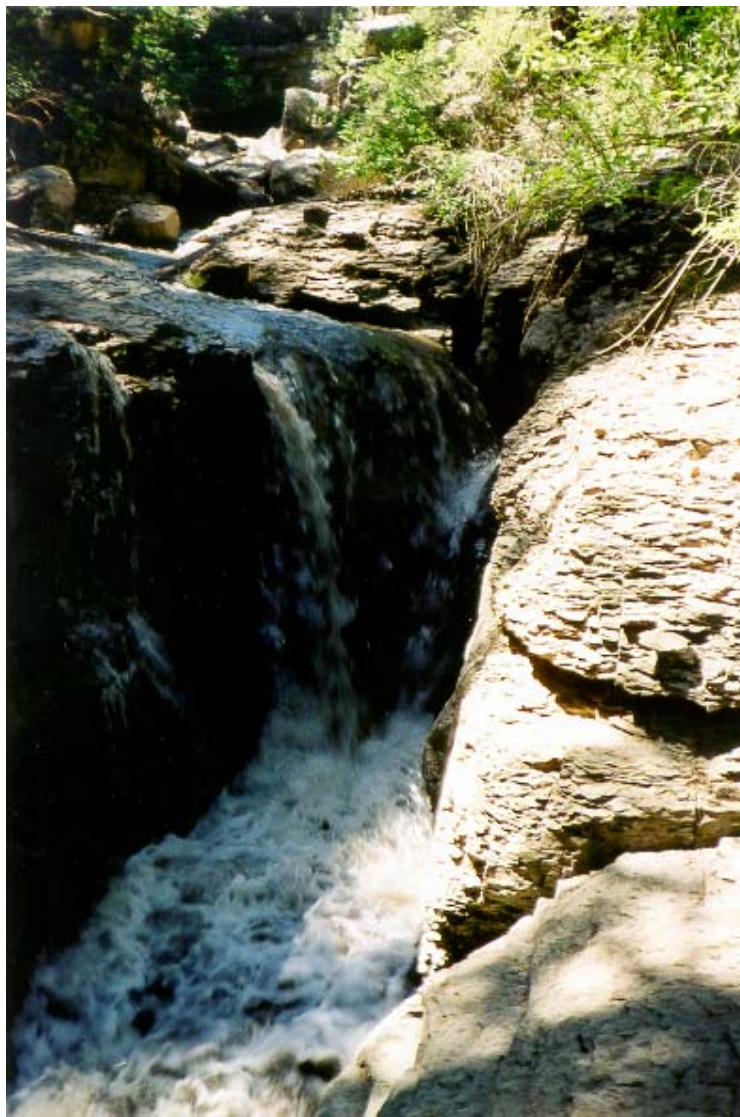
Photo 18. Reach 3, NSO50, F7. Waterfall (8' high) that acts as a barrier to fish passage due to its confined channel and shallow depth at splash (30 Jul 2001).

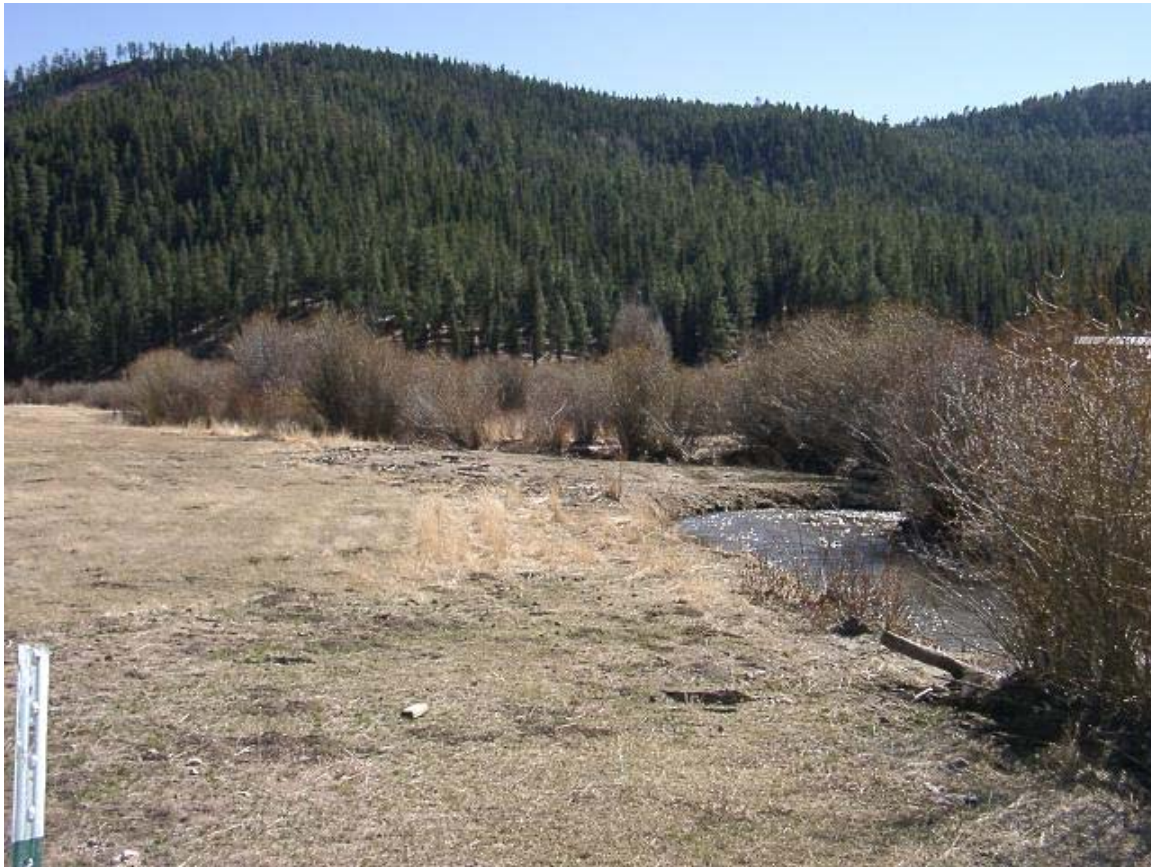
Reach 4 is an open pasture on private land. Bank vegetative cover within the reach is low, resulting from private land management practices, namely grazing. Vegetation in the reach consisted of grasses and willows. Plant vigor within the reach was low, stemming from grazing impacts.

Photo 19. Downstream view of the upper end of Reach 4, as seen from Road 86 (Spring 2002). Note: grazing effects on riparian vegetation.

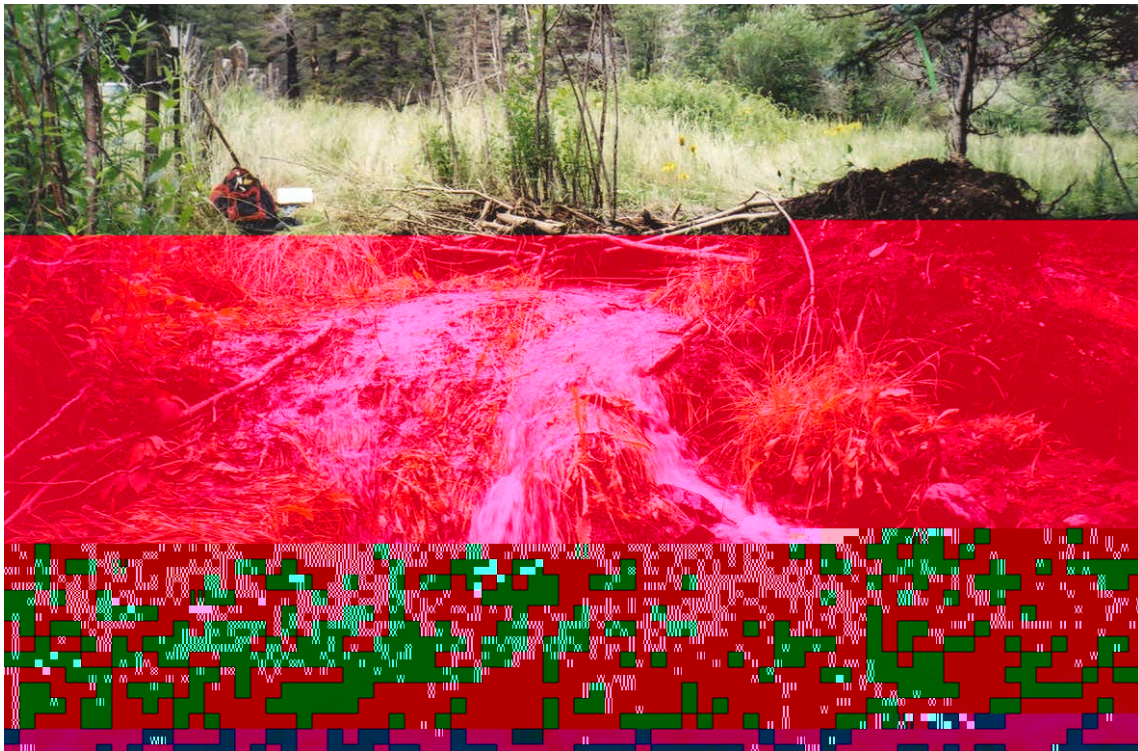
Photo 20. Reach 8, NSO132, T12. Tributary that has formed a new channel through grass (14 Aug 2001).

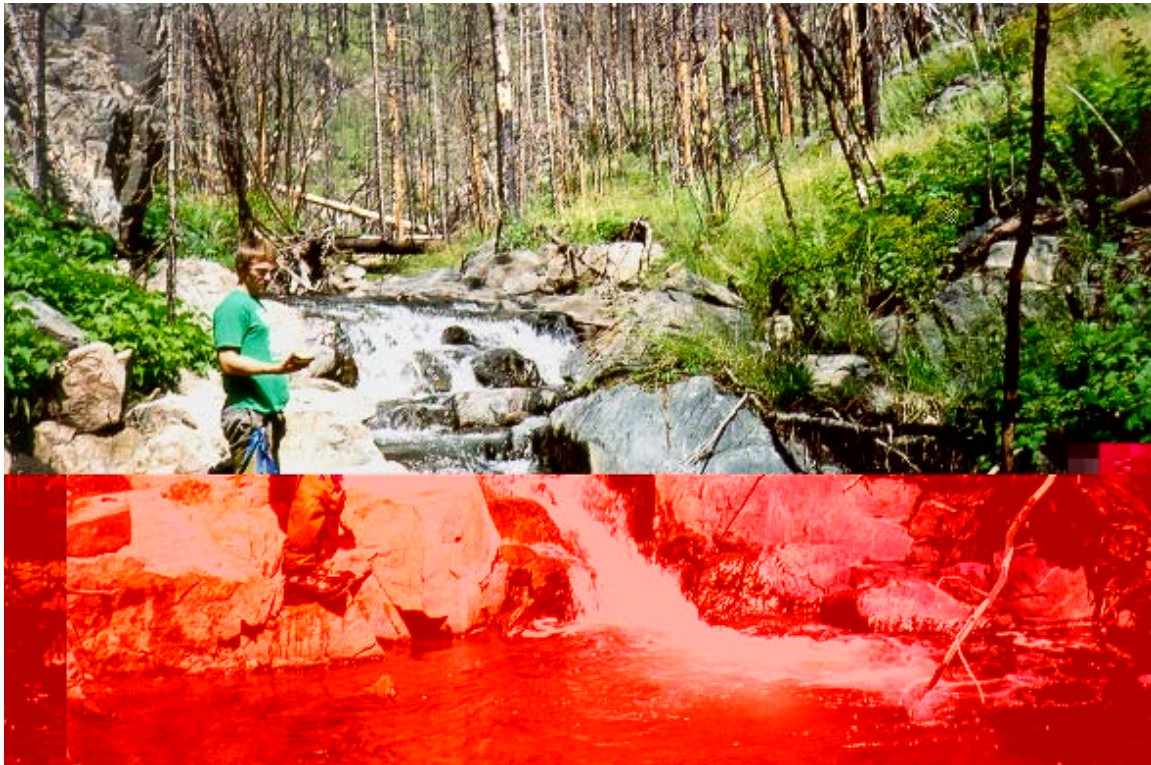
Photo 23. Reach 10, NSO239, F10. Chute just upstream from the mouth of Elk Creek. Note the fire-damaged trees in background (27 Aug 2001).
